Ask for: Joshua Brown-Araque
Email: Joshua.Brown-Araque@Ashford.gov.uk
Direct line: (01233) 330 442
Date: 14/05/2024
Ref: Parcels A, E, F, C2 & NG1 Land at Chilmington Green

RE: REF: Quality Monitoring Site Visit: *Parcels A, E, F, C2 & NG1 Land at Chilmington Green, Ashford Road, Great Chart, Kent*

I am the Quality Monitoring Officer at Ashford Borough Council and I am based in the Placemaking Team within Spatial Planning and the Planning and Development Department. It is my role to help ensure that all aspects of the quality of the Developments at Chilmington and South Ashford Garden Community meets the high planning and design expectations originally envisaged here.

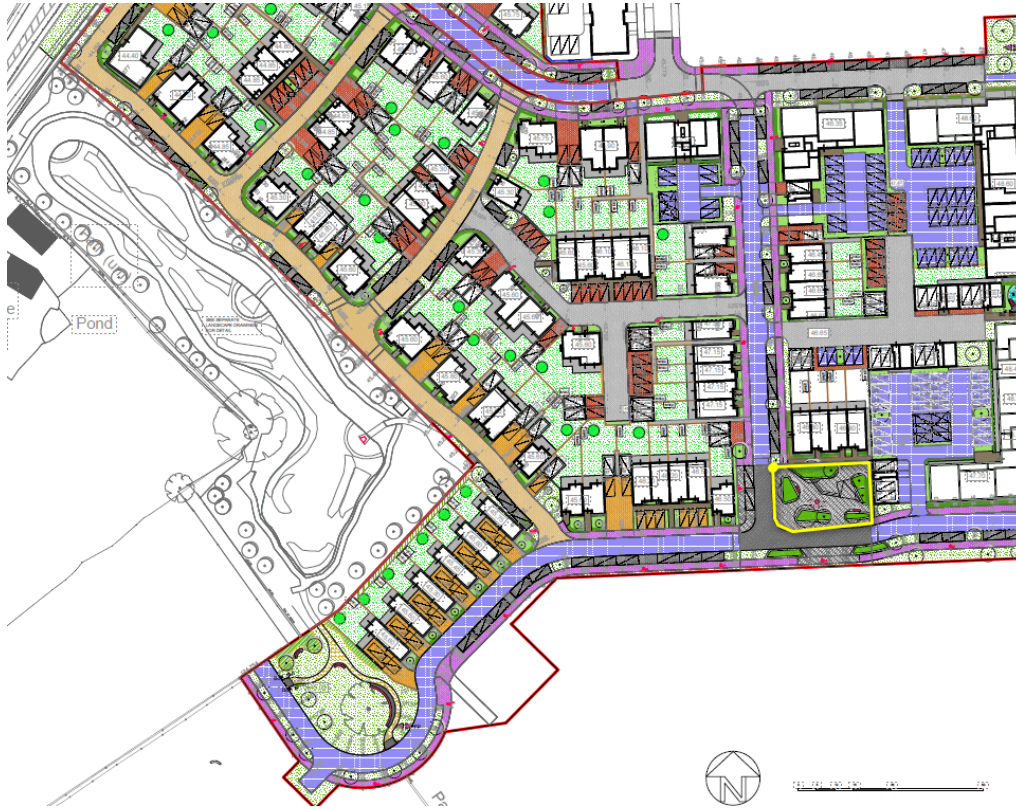
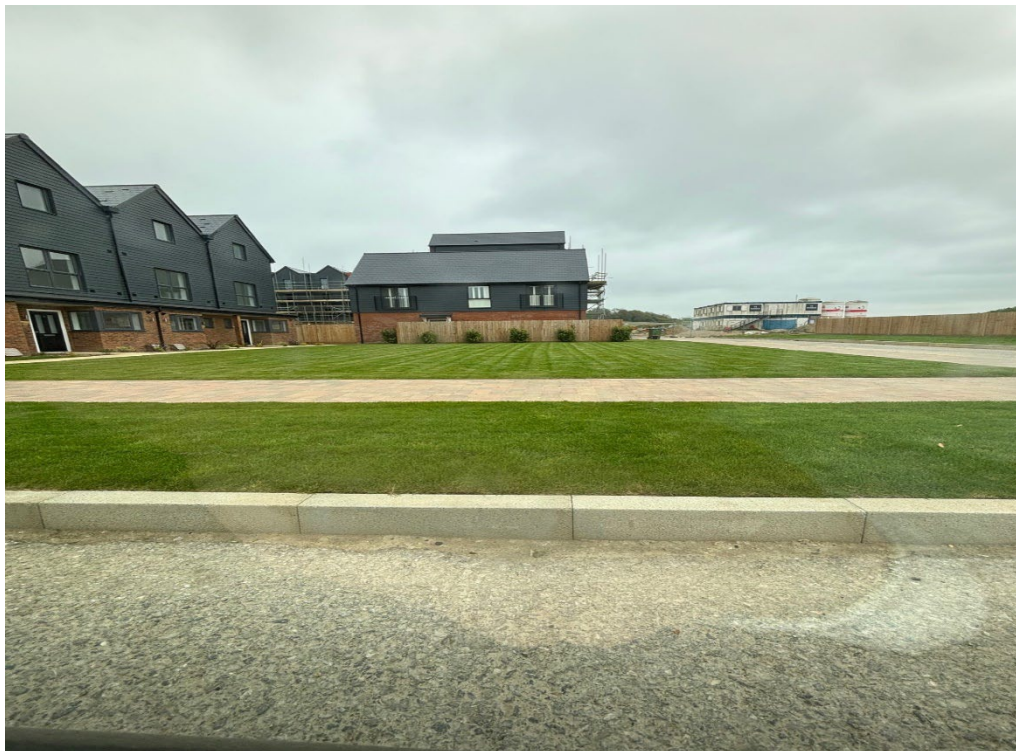
- 1) To the southeast of the site there is an area which is grassed with three properties fronting onto this open space. Drawing (*URBAN SQUARE HW - D0367_001 A and URBAN SQUARE SW - D0367_002 A*) shows this area to have six proposed semi mature multi – stem specimen trees (Zs) (Pp) (Ttb – street trees) also proposed is groundcover ornamental planting to urban square beds. Also proposed in the hardworks document is shared surface paving, urban square paving, cast stone concrete seating and retaining planter walls with hardwood timber seating tops, precast concrete steps and a bin (B). Currently this area is just grassed. Is there a date that the above will be installed? If not is there a reason why no works are yet to be carried out to provide the Urban Square? ***(Please see below for photographs and location)***

1) Grassed area to the southeast of the site. (Located within the yellow boundary line below).

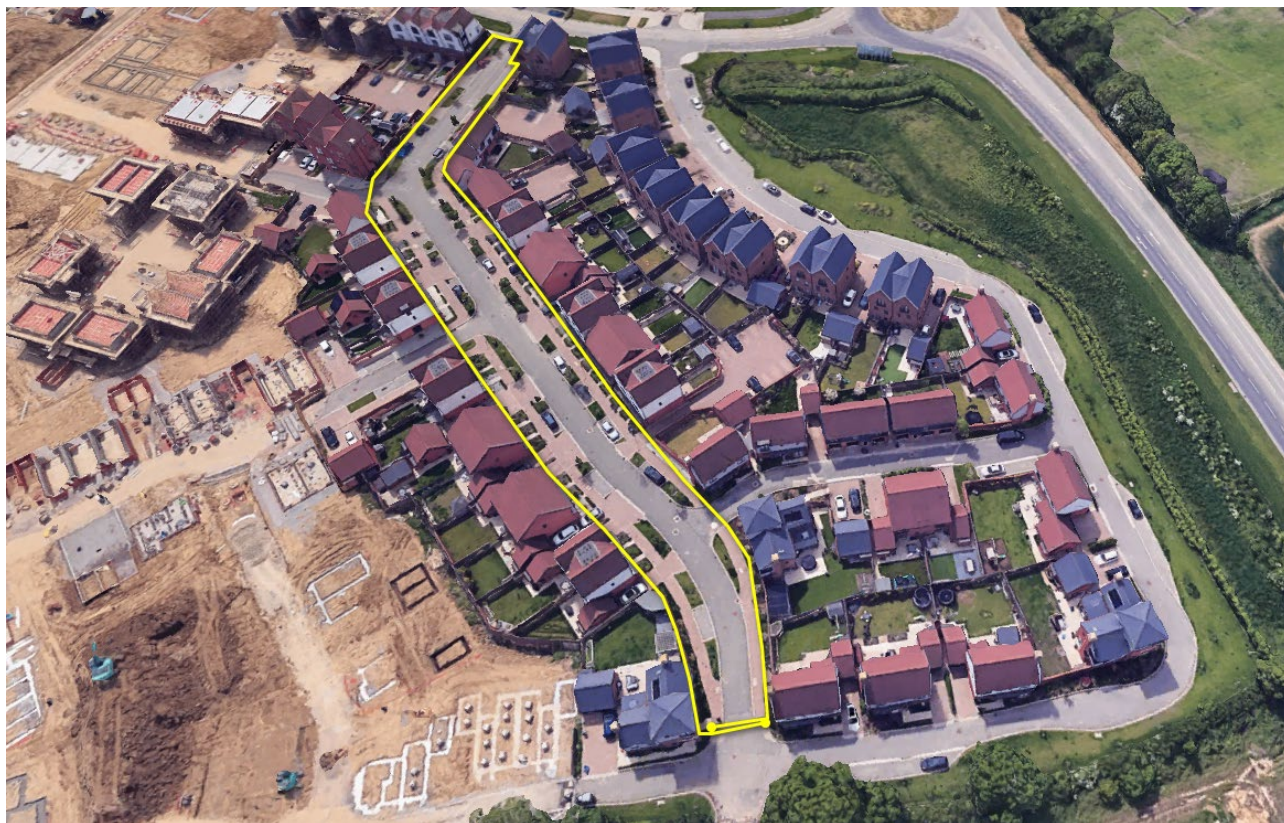
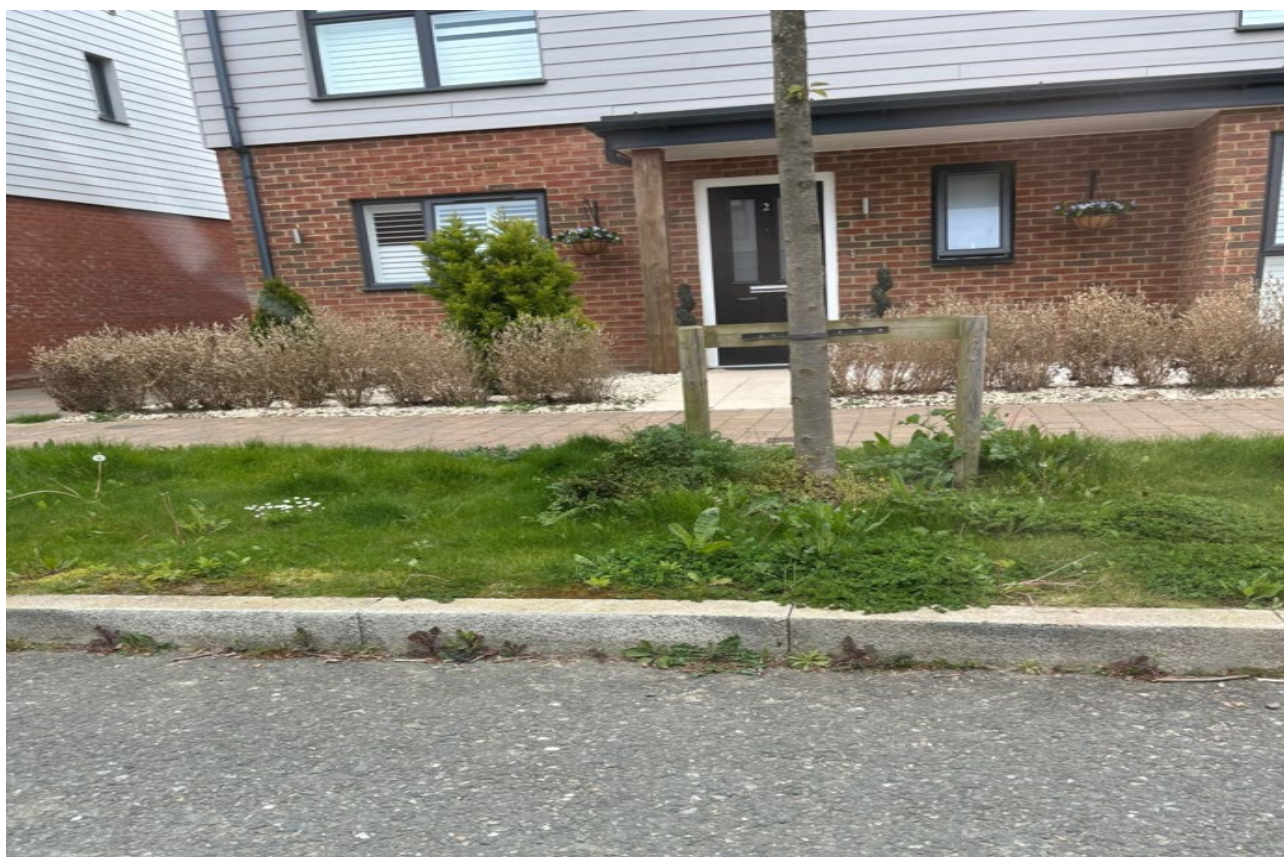
- 2) 1. Along woodland rise there are a number of street trees with small grassed areas (26) which are significantly overgrown, with a number of weeds etc. who maintains these areas and how regularly are they maintained as they look like they have been left for some time without any maintenance. ***(Please see below for photographs and location)***

2. Also to note the curb line along the roadway on woodland rise also have a number of weeds growing out of the bottom of the curbs. This area looks poorly maintained and needs attention. ***(Please see below for photographs and location)***

2) 1&2 Woodland rise street tree pits & grassed areas.(Tree areas located within the yellow boundary line)

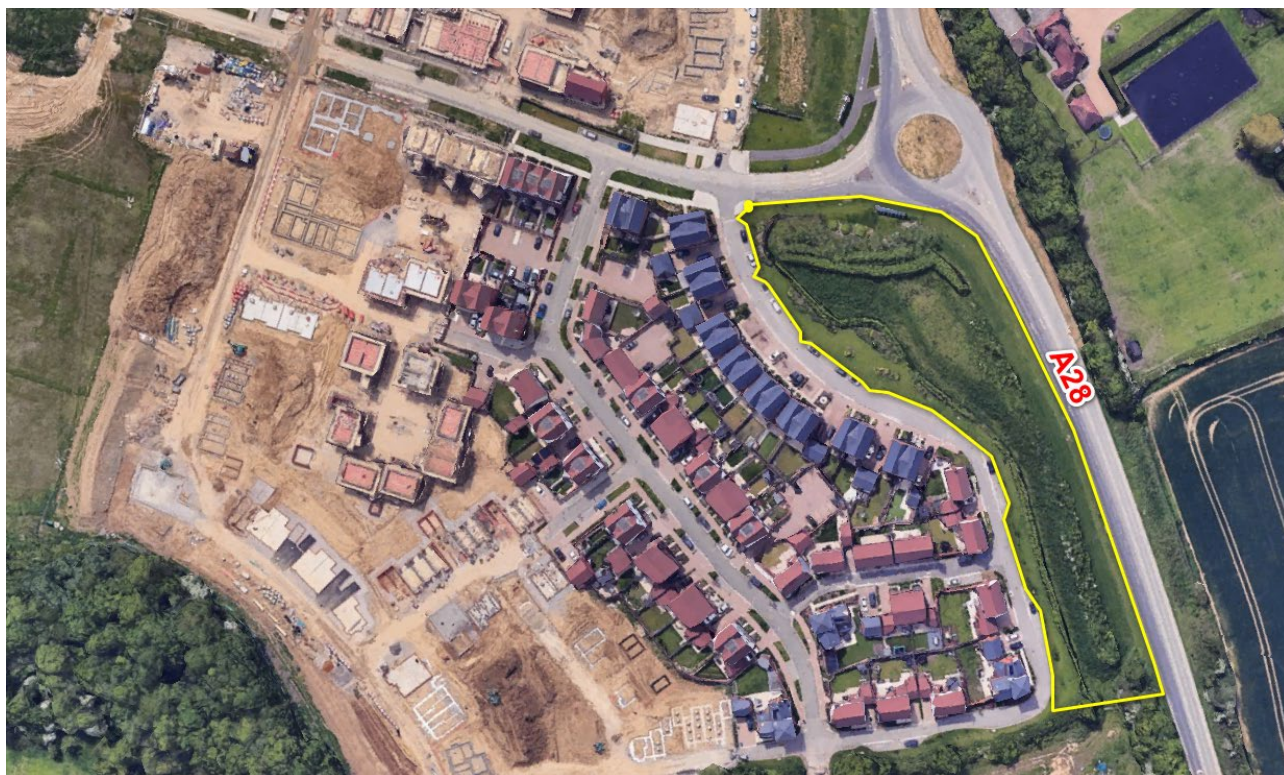
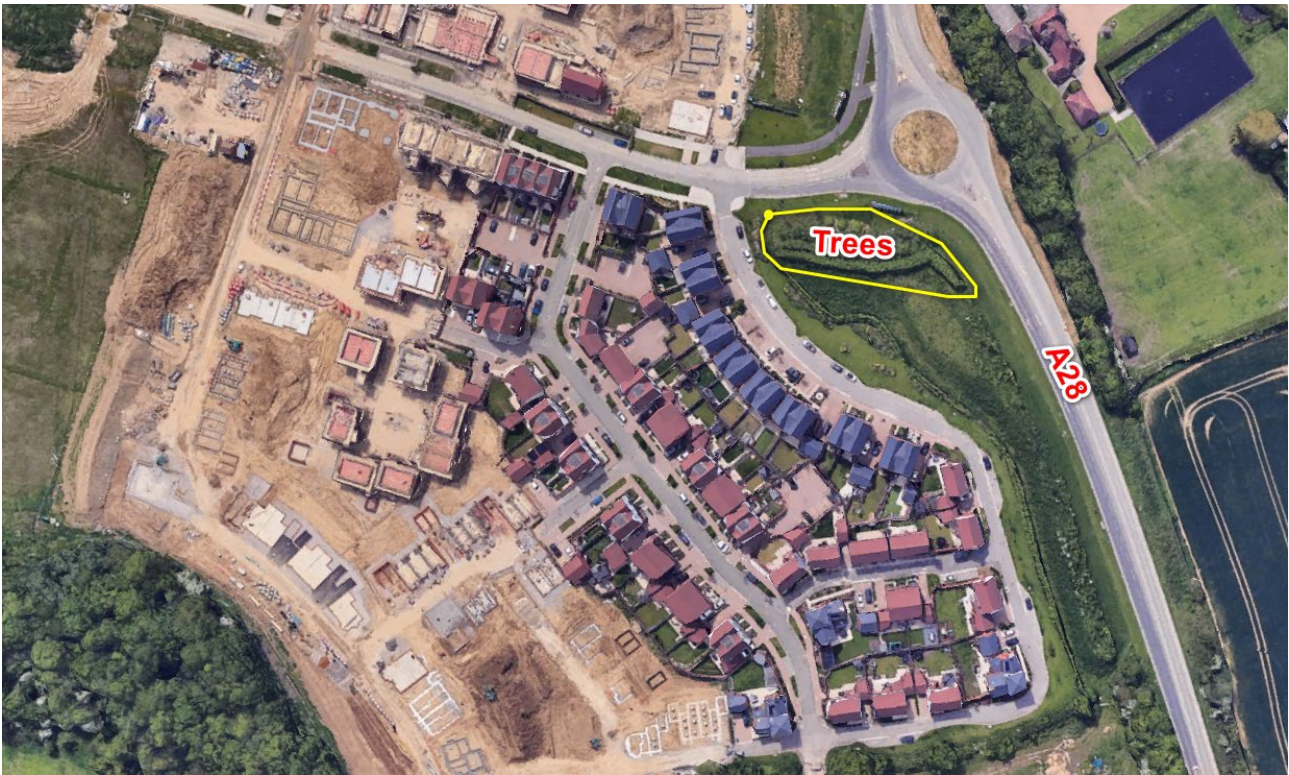
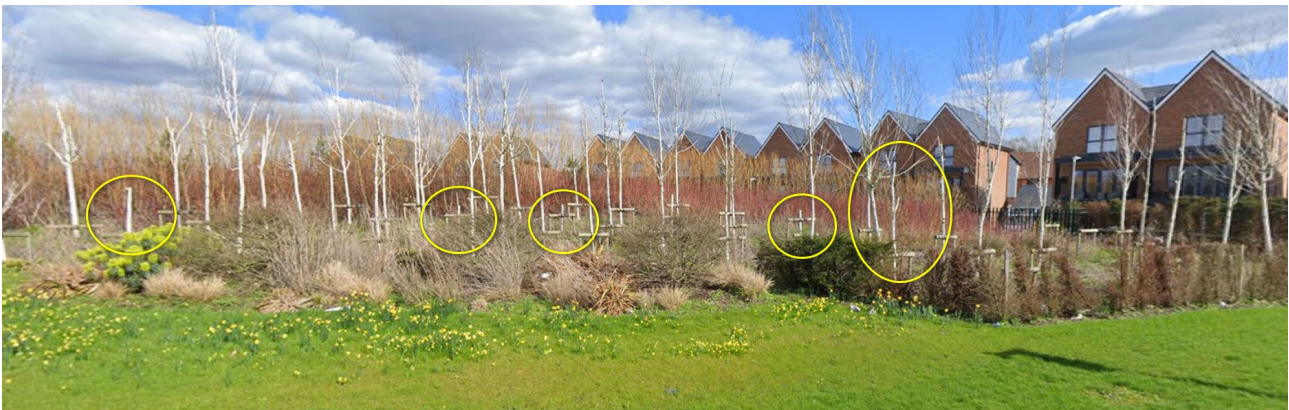
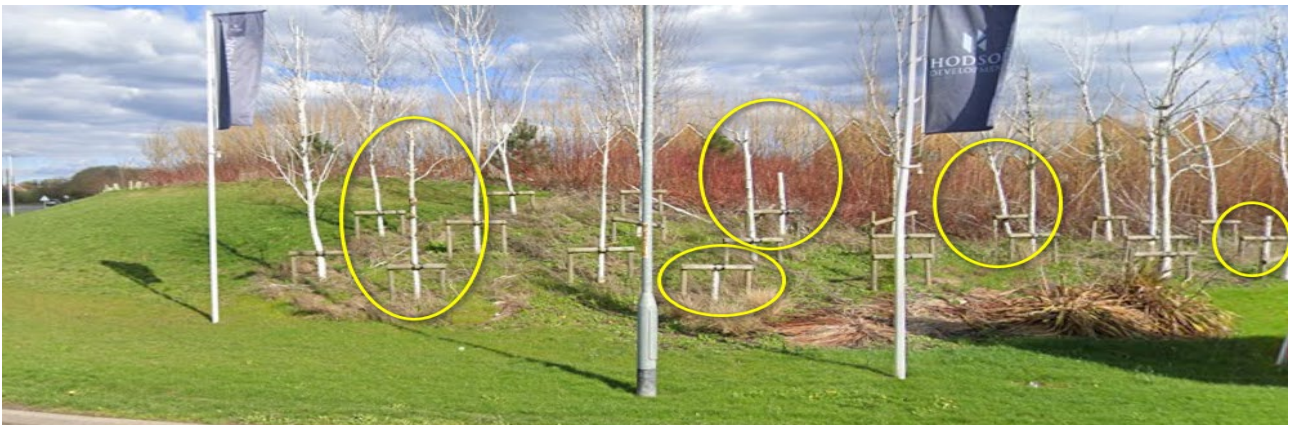
- 3) On the entrance bunds/banks (NG1) nearest to the northern access off the A28 a number of trees appear to have died/snapped. I am unable to say how many have died due to accessing the area but from the road side it's clear there are multiple trees which will need replacing. Who maintains this area and how regularly is this done? Please note that this area does not benefit from RM consent and I am in no way agreeing or consenting to what is in place. ***(Please see below for photographs and location)***

- 3) *The entrance bunds/banks (NG1) nearest to the northern access off the A28 (Trees located within the yellow boundary line) Also see photographs of trees.*

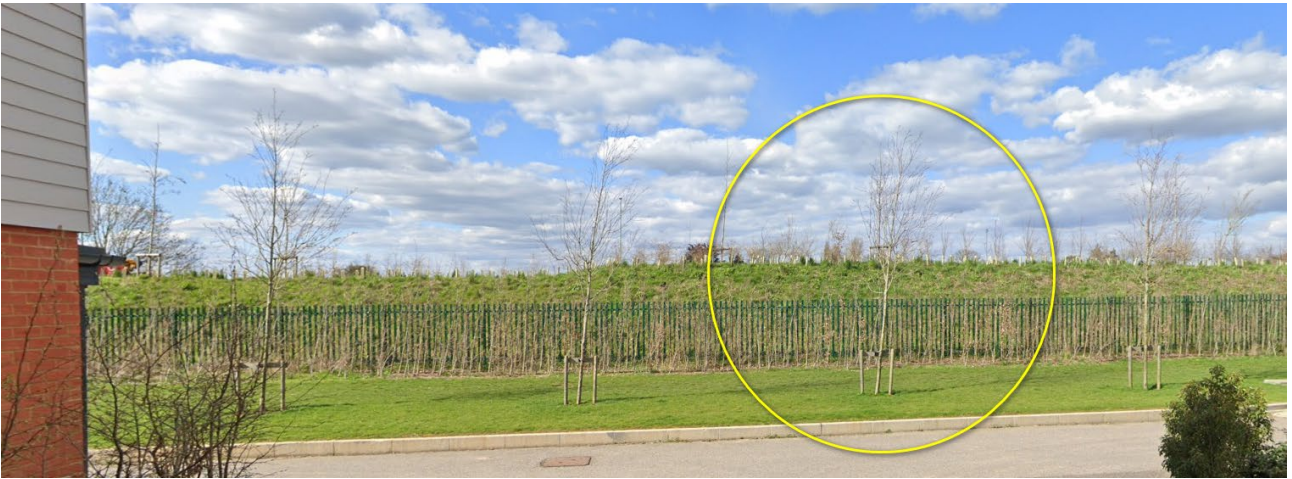
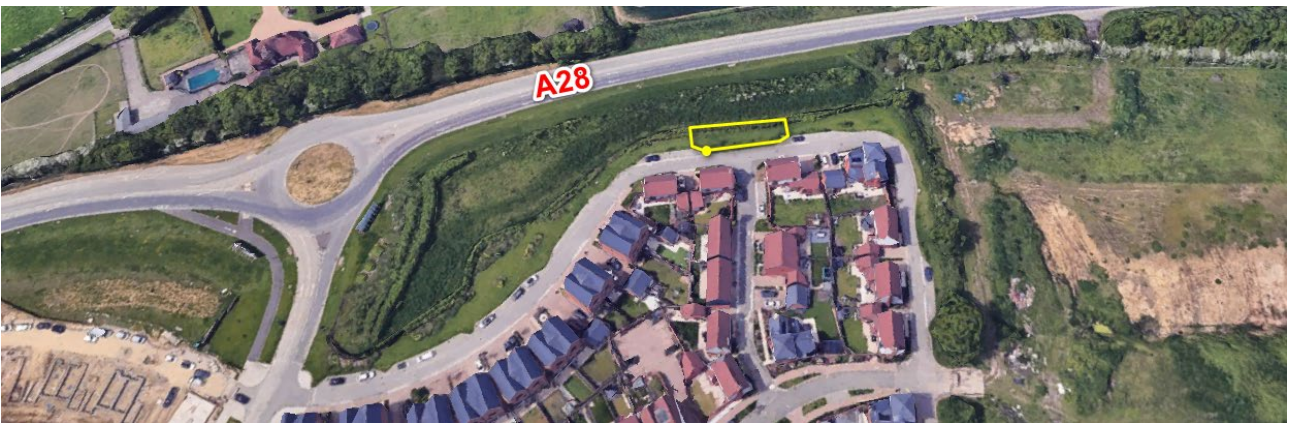
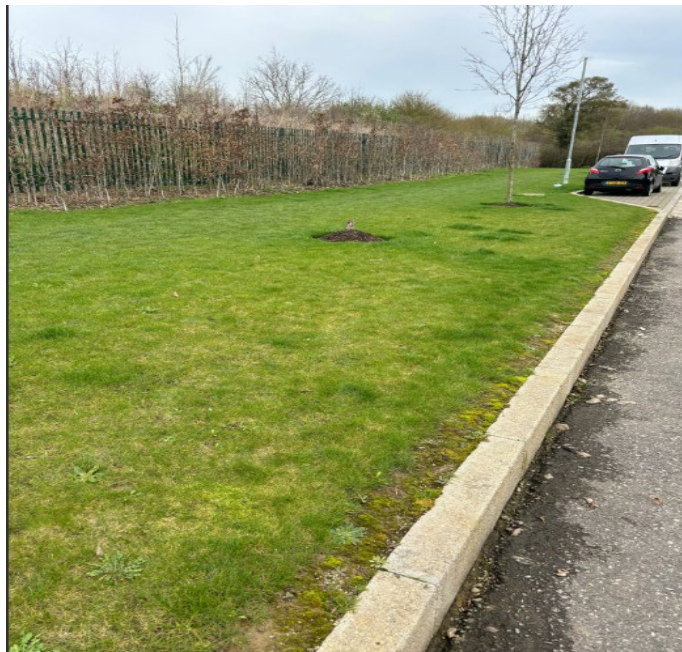
- 4) To the norther edge of the site nearest to bund/banks alongside the A28 (NG1), a singular street tree has died/broken and is now at ground level. This tree is a part of a row of four trees and without this there is a gap in the row, the street trees are large in size and are a view point at the end of Green mews. It will need to be re planted to maintain the row of trees. ***(Please see below for photographs and location)***

4) The norther edge of the site nearest to bund/banks alongside the A28 (NG1), a singular street tree has died/broken

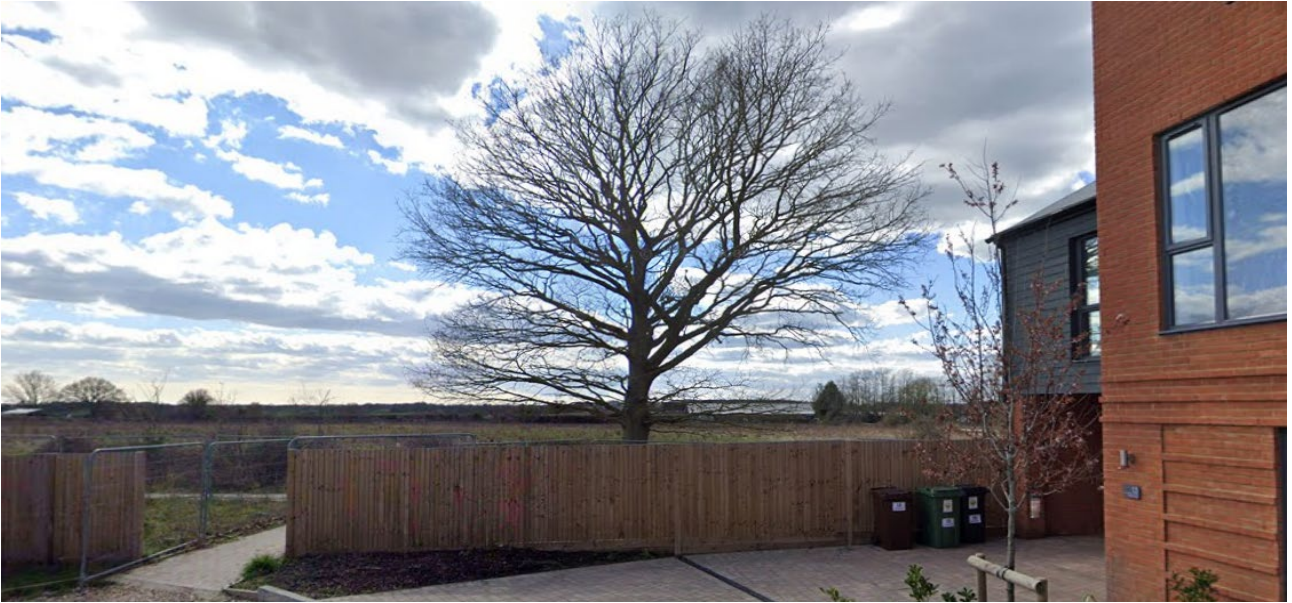
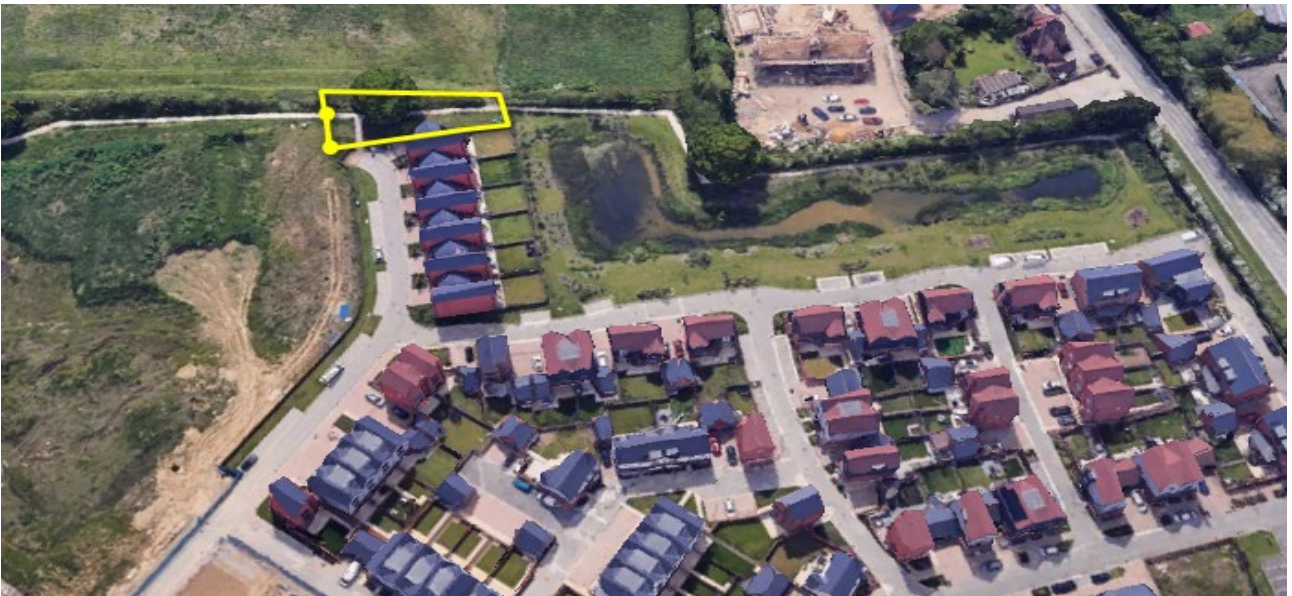
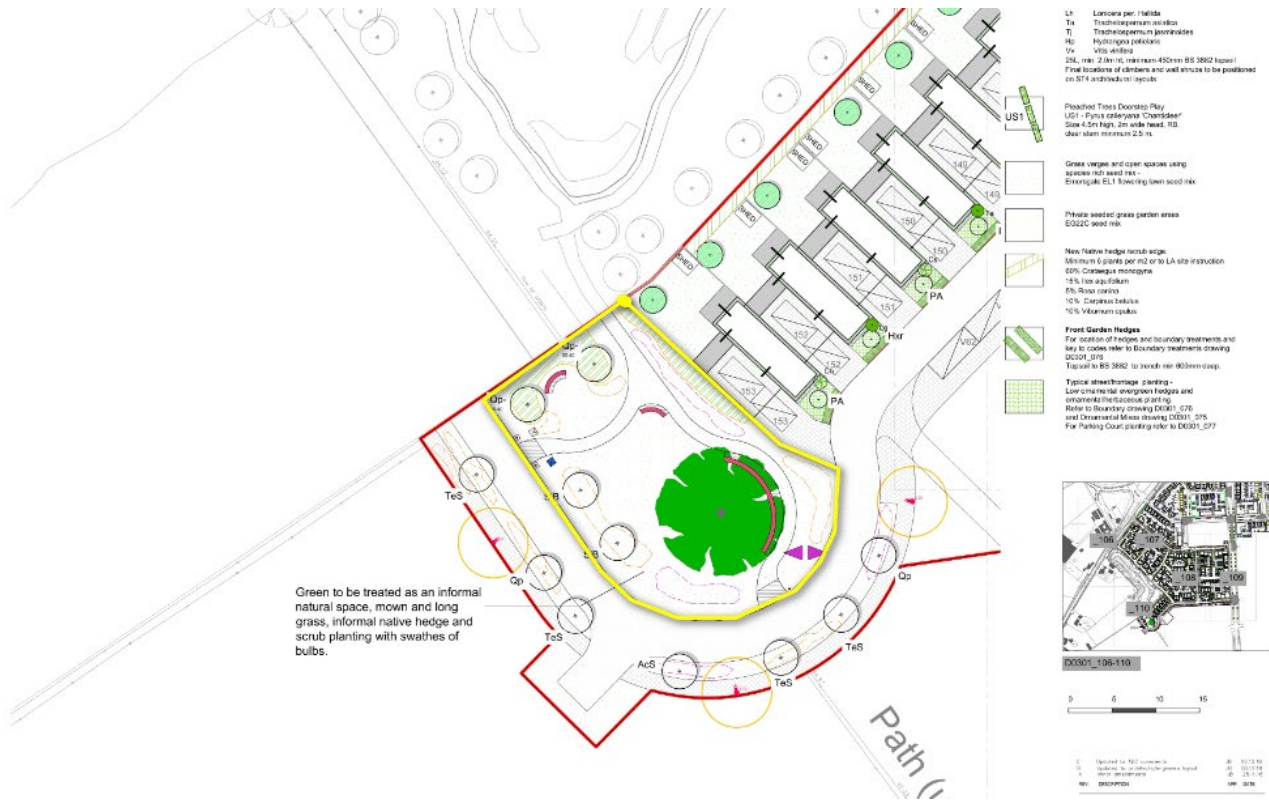
- 5) To the south eastern corner of A, E and F is an area alongside plot 153, there is a large mature Oak tree (Tree in situ on the site before development had started and TPO Tree), The tree is currently behind a close boarded fence with a pathway which goes around the tree and to the SuDs feature (C2) via two pathways, and in future development a highway will also loop around the tree. Currently this tree does have a pathway from the roadway but it does not look like what was originally proposed (LANDSCAPE GA SOFTWORKS 5 OF 5 - D301_110 C), there is harries fencing surrounding one side of the tree, no proposed litter bins seem to be in situ, and benches also seem to not be in situ in this area. Also proposed is further trees which also do not seem to be in situ. Please could you confirm when this work will be completed? This area is a key connection and open public space so it would be ideal to progress this area for residents currently living on site. ***(Please see below for photographs and location)***

- 5) To the south eastern corner of A, E and F is an area alongside plot 153 – large mature Oak tree (TPO).

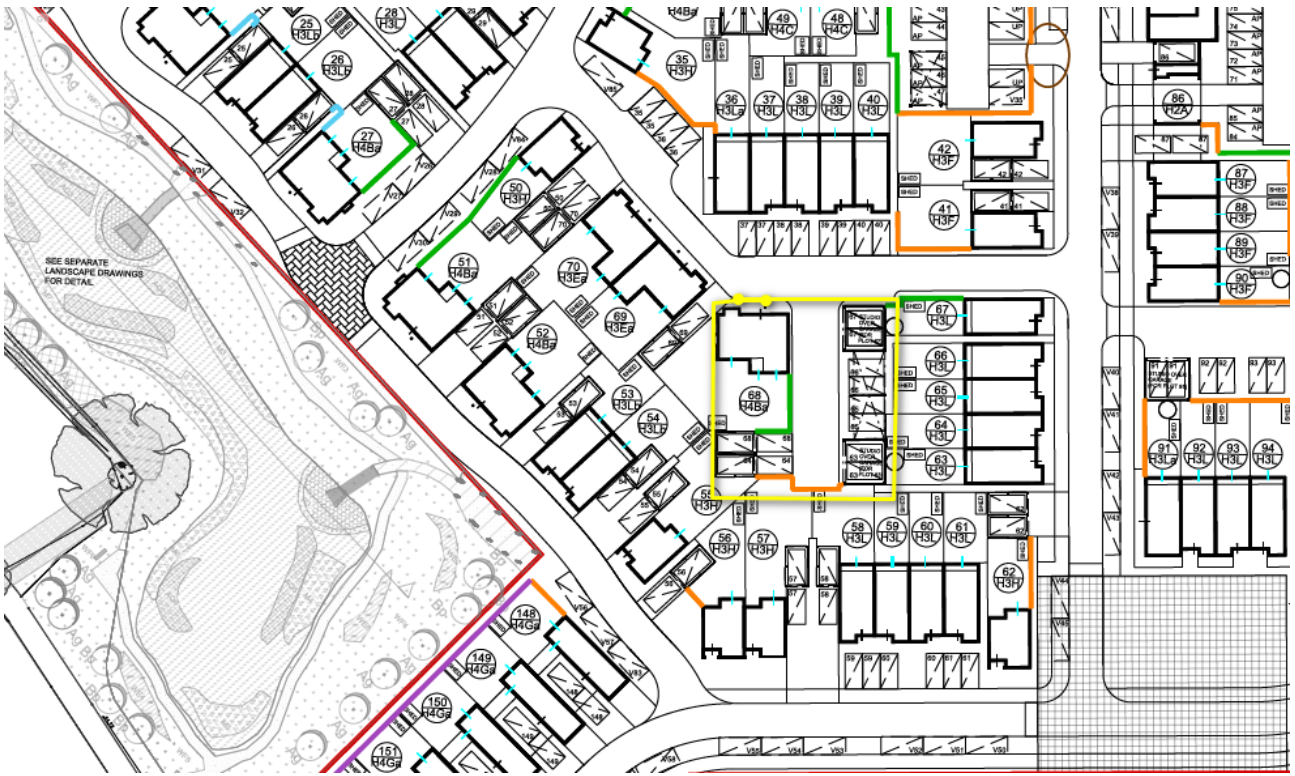
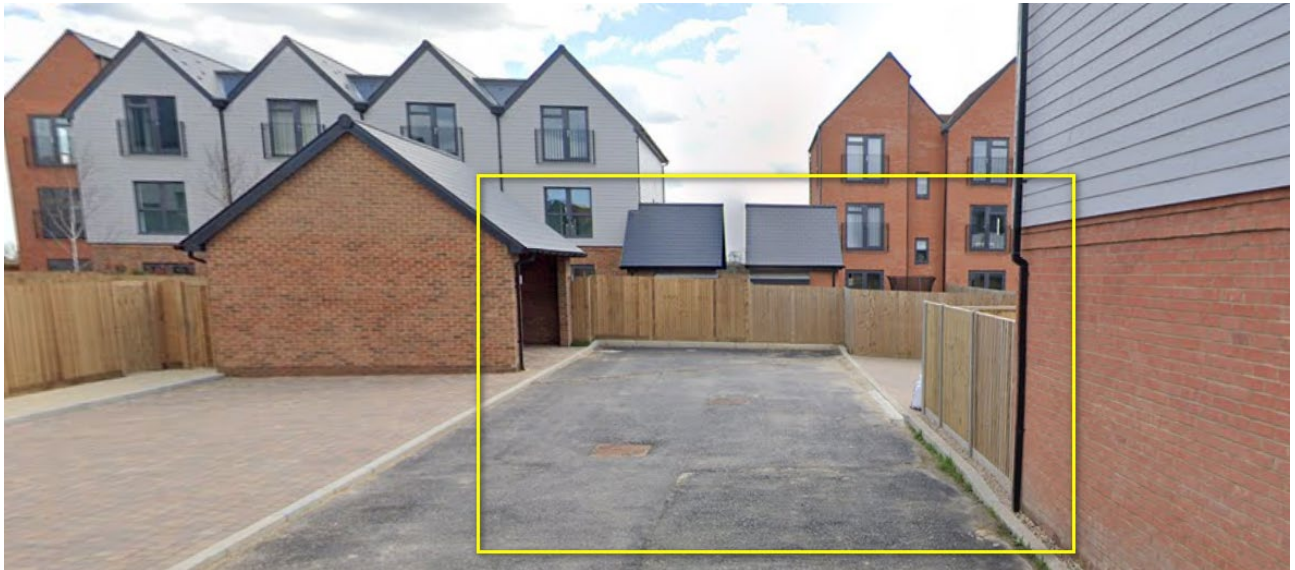
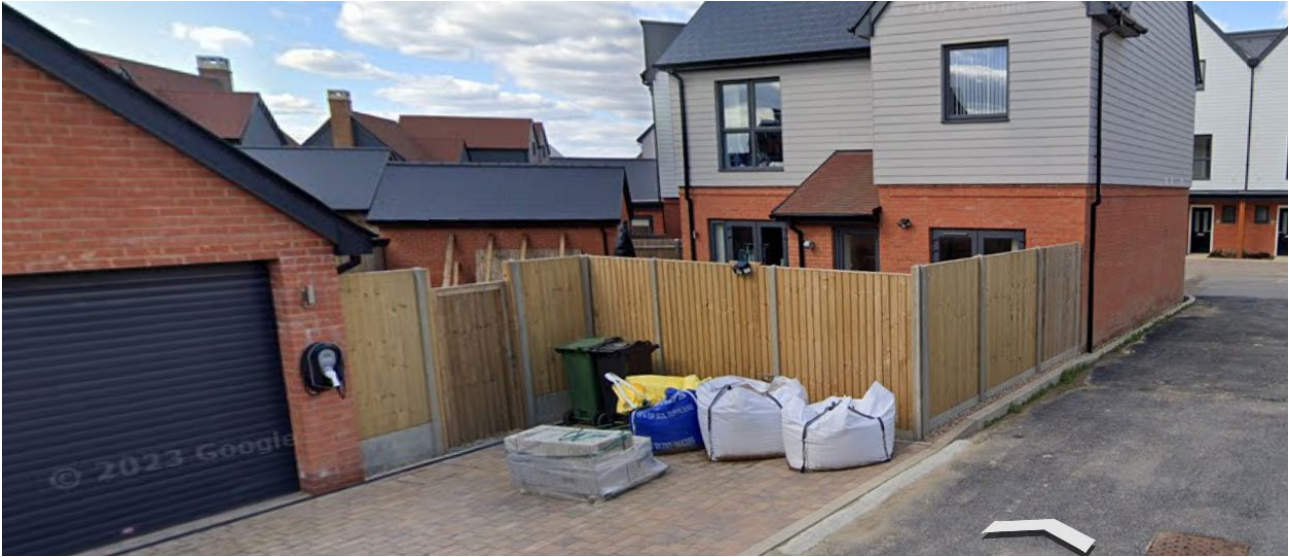
- 6) To the south east of A, E and F off Oakwood Mews, is a parking court area with two garages and parking spaces in between the garages. The boundary treatments in this area are close boarded fences. On the boundary treatment plan (Drawing No. 00122S_MP09) in this particular area shown below where to be proposed (Brick Wall 1.8M) and (Brick Wall with Planting 1.8M). Is there a reason why close boarded fencing has been used? Has the boundary treatment plan been revised to show close boarded fencing? Also has the owner

of plot (68 H4Ba) erected a new fence as it appears to be different from other fences on the site? ***(Please see below for photographs and location)***

6) To the south east of A, E and F off Oakwood Mews – Boundary treatments

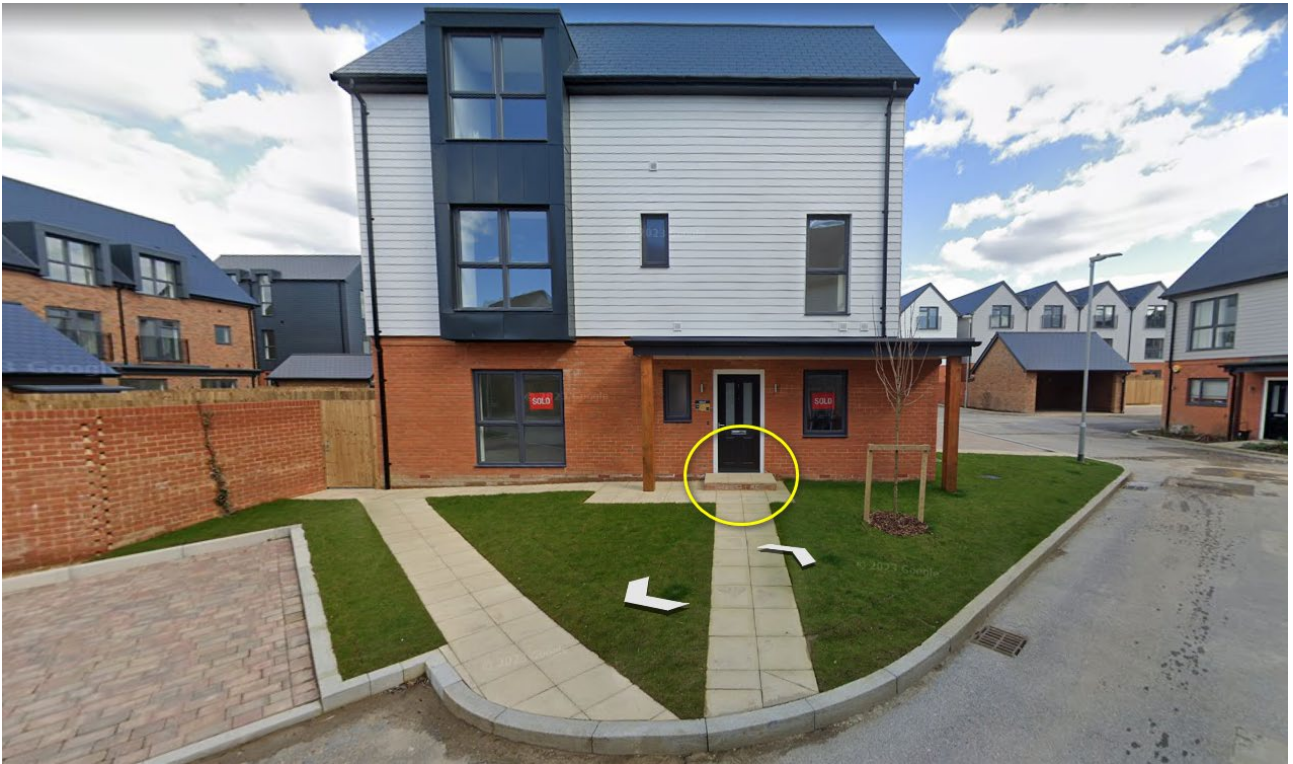
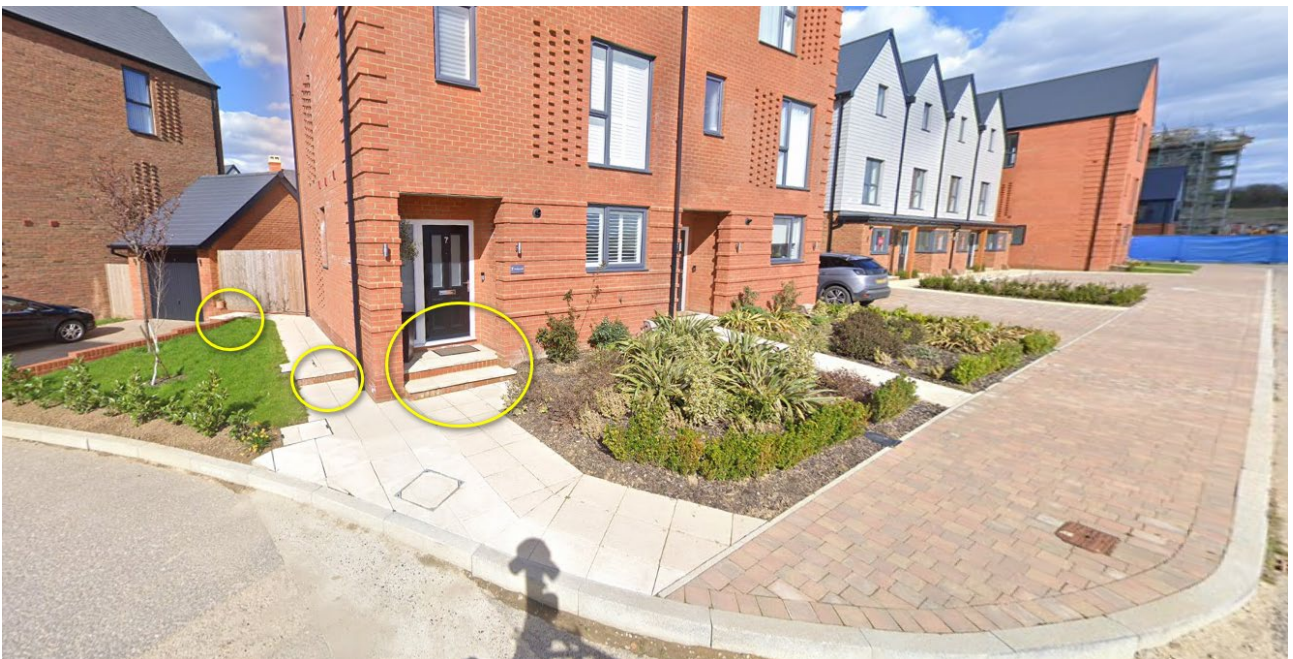
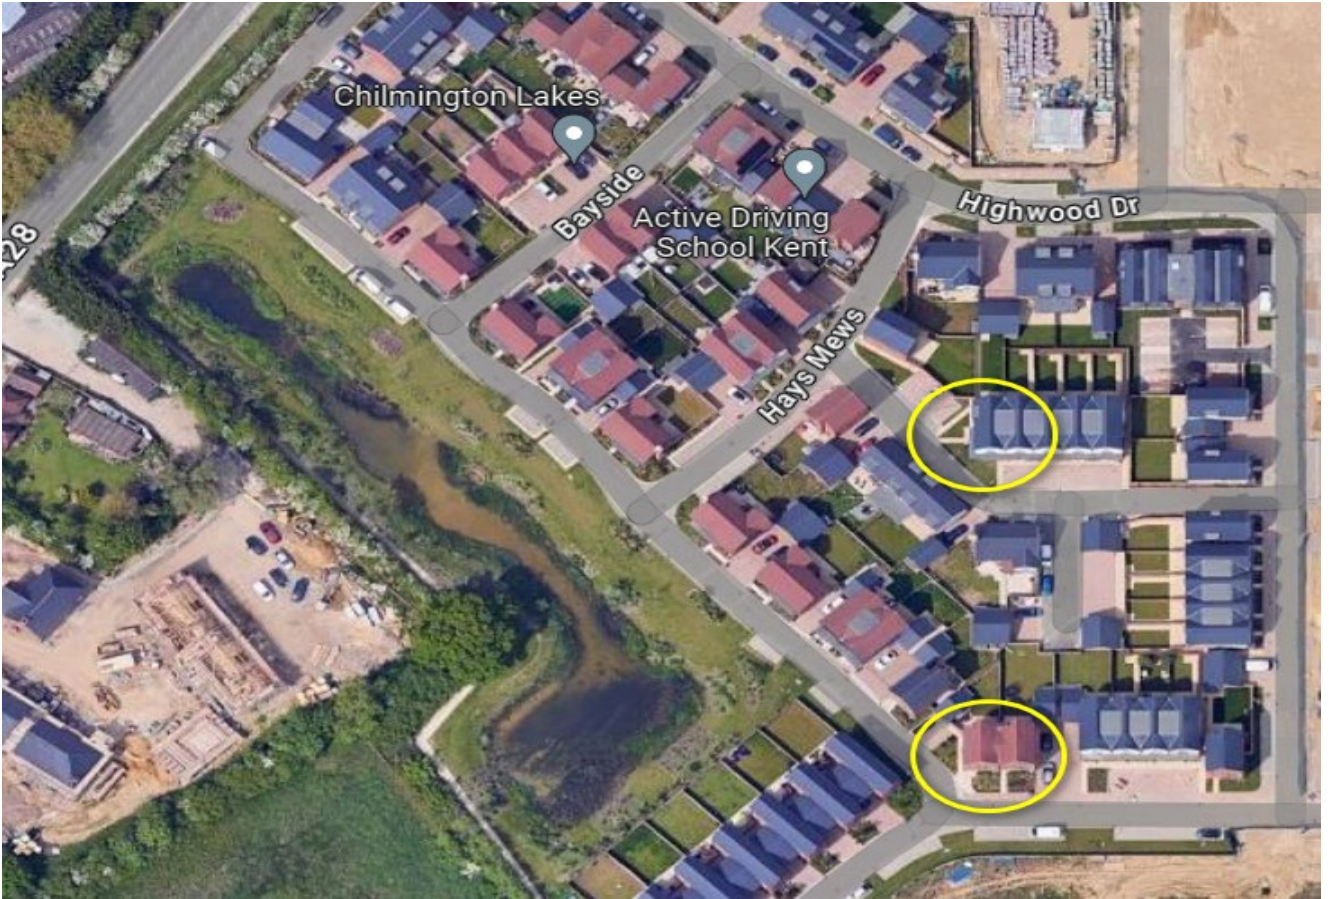
- 7) On Plot 36 H3La off Oakwood Mews, the entrance into the property is stepped, as shown below. Is the large step necessary as it could potentially cause accessibility issues, why did this property not have level access? Also included below is a further example of a property on site with three access points which are stepped. Please refer to Condition No. 51 requires details to be submitted at the RM stage to demonstrate that all dwellings will be provided with level access. ***(Please see below for photographs and location)***

7) On Plot 36 H3La off Oakwood Mews, the entrance into the property is stepped.

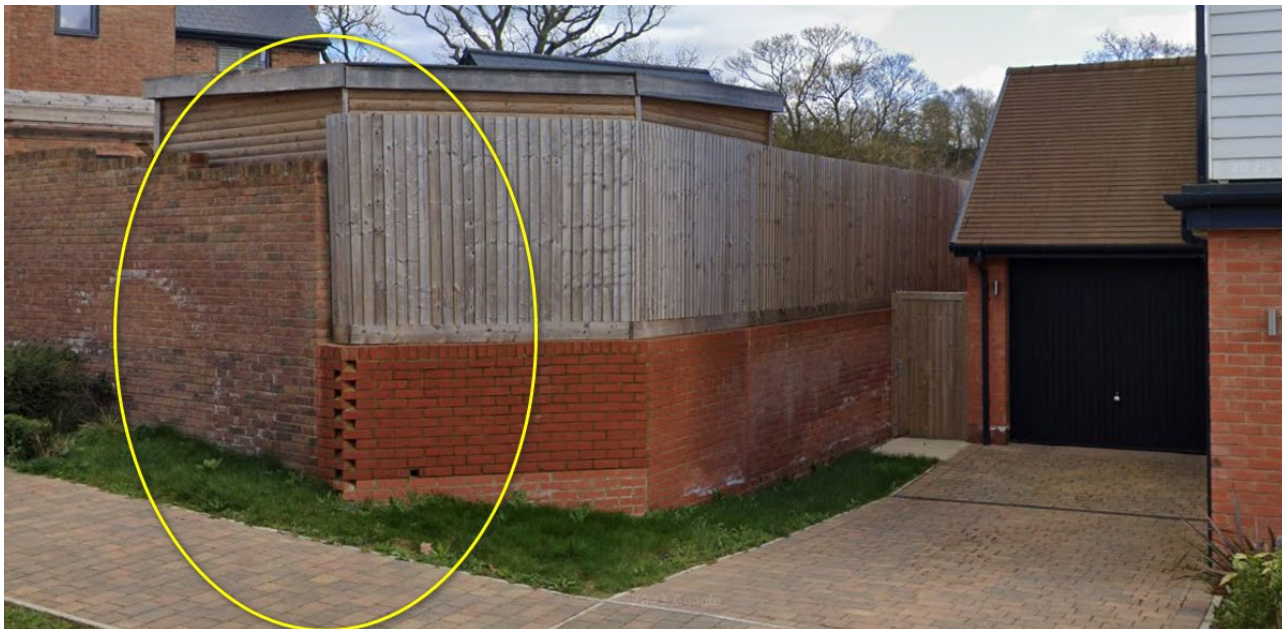
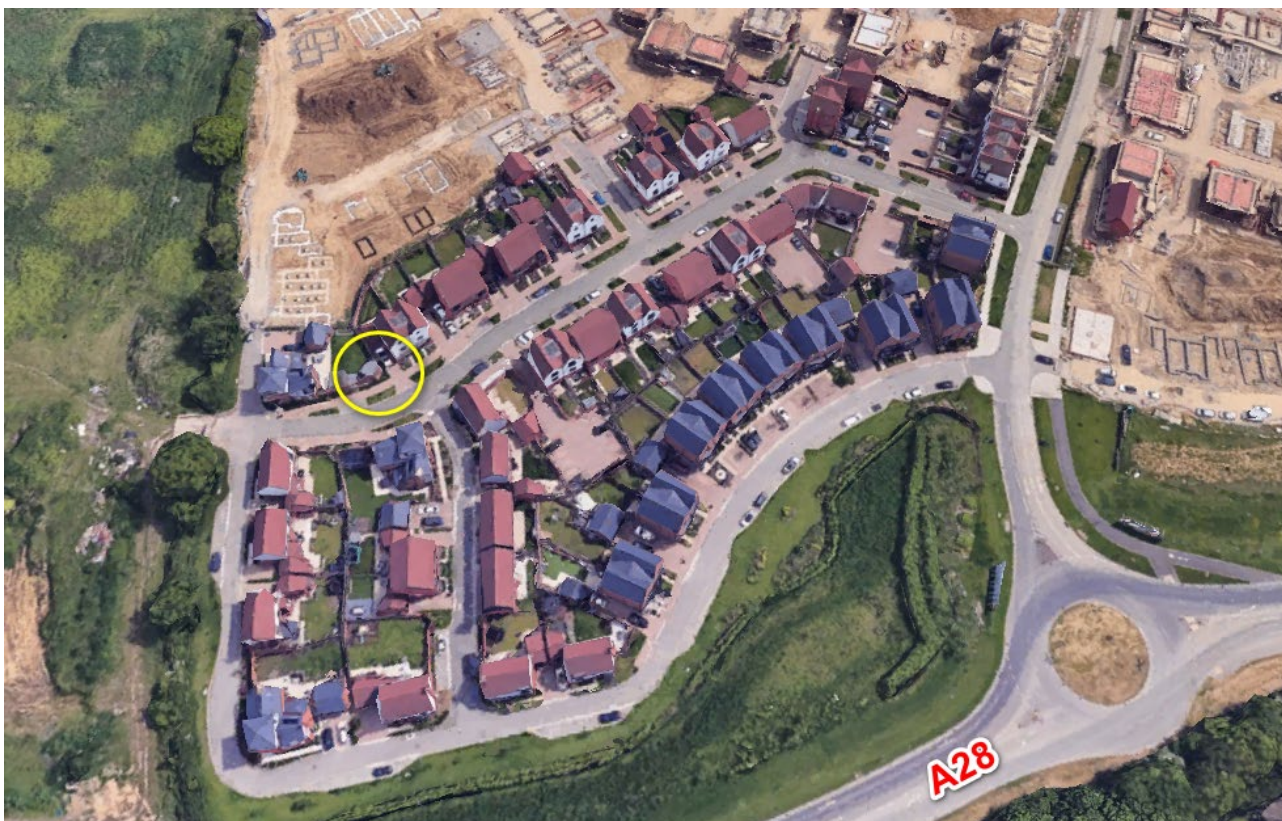
- 9) Nearest to No. 26 Woodland rise are two brick walls, one is enclosing a garden and one is enclosing a driveway for No. 26 Woodland Rise (This wall has a closed boarded fence on top of the brickwork). There is a significant colour difference in brick between the two adjoining brick walls (as seen in the photograph). Is there a reason why there is such a difference in brick? Future walls should be built in brick to match adjoining brickwork. ***(Please see below for photographs and location)***

9) Nearest to No. 26 Woodland rise are two brick walls
